Franklin Regional Transit Authority

Operations Facility Needs Assessment

June 2012

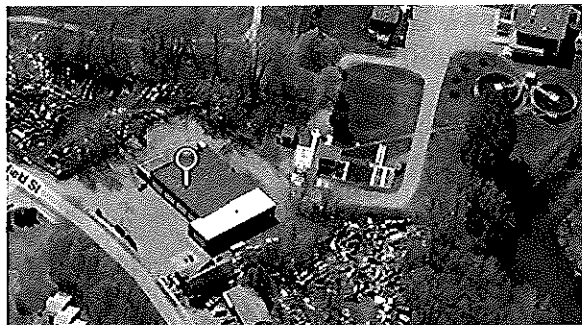
The existing site at 382 Deerfield Street is considerably smaller than required to allow FRTA to operate with any reasonable degree of productivity. The site does not support any separation between circulation of visitor vehicles, employee's private vehicles, and FRTA's operations vehicles – a critical planning criterion for any modern fleet operations facility. The smallness of the existing site also means that all space not taken up by buildings functions as a parking lot during service hours (visitors, employee vehicles, buses between routes) which creates a significant level of conflict.

The site is not secure. There is an easement across the Operations Facility site which provides access to the Waste Water Treatment plant located to the south, along the Green River. This easement prevents FRTA from erecting a fence around the facility or the operations yard, which means the facility, and any vehicle left out of doors, is vulnerable to vandalism. In addition, since the site is open to the street, the general public regularly uses it as a convenient turn-around point, which introduces an unpredictable, additional vehicular circulation component – one that can be particularly dangerous.

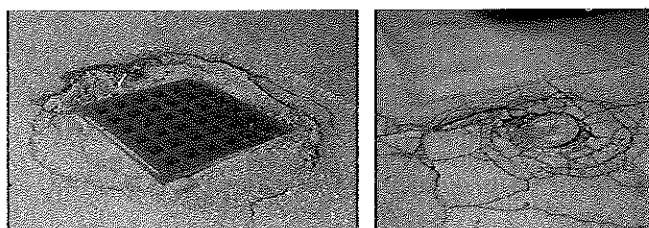
The site is unstable. There is a continuing problem with pavement subsidence around the Operations Facility. The subsurface below pavements in many locations continue to sink, which causes cracking and deterioration of pavement surfaces, and failures around manholes and other subsurface structures. This problem is an on-going maintenance problem.

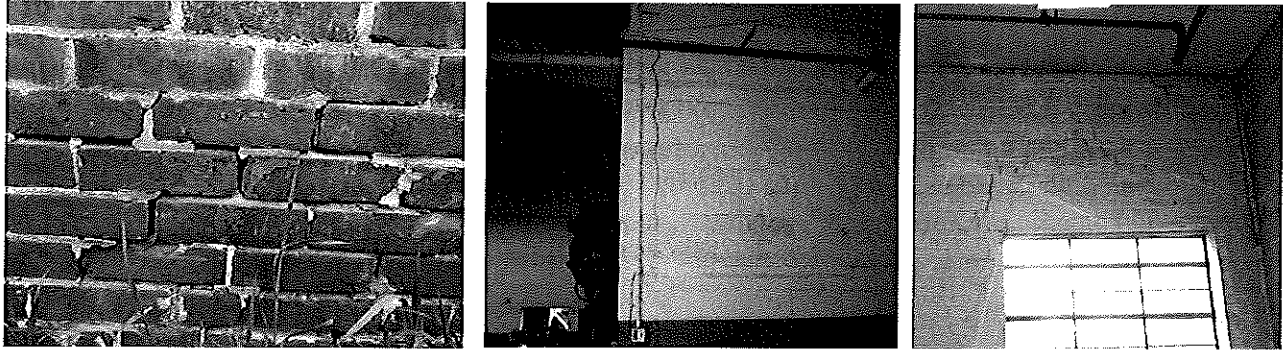
Most of the building envelope (roof and walls) is more than 100 years old. In many places the existing exterior brick masonry shows signs of significant deterioration, including diagonal cracking (which points to building settlement), spalling, and failed mortar joints. Interior concrete block masonry also shows signs of diagonal cracking, some of which has been repaired.

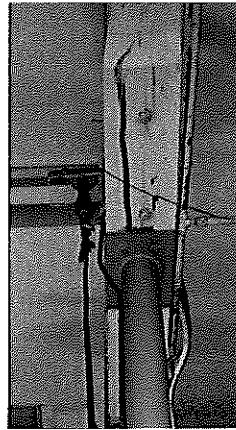
In addition, there is evidence of failures in a number of elements of the original wood roof structural frame. In the western portion of the 1913 building which houses maintenance bays 5-8 and the boiler room, the line of original 12" x 12" wood columns have significant longitudinal splits, which reduce their load carrying capacity. In addition, the 12" x 12" x 6' wood column headers which transfer gravity loads from the roof rafters to the columns also have longitudinal splits that appear in some cases to pass through the entire thickness of the member. In the eastern portion of the 1913 building which houses bays 1-4 the original wood columns have been replaced with steel lally columns, presumably because of the splitting of the original wood columns had become so advanced to require action. Unfortunately, the original wood column headers remain, and nearly all show signs of advanced splitting.

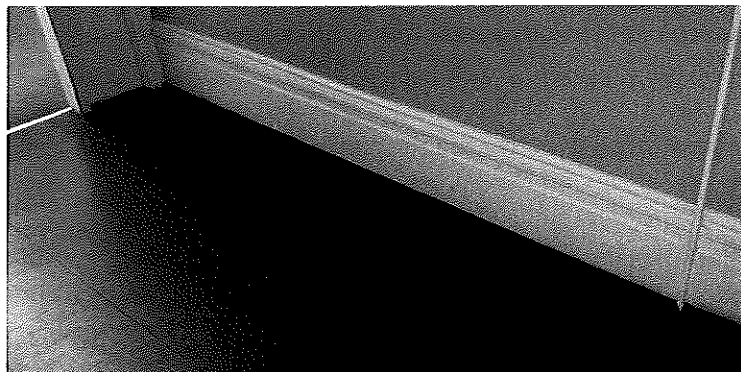
At one location within the administration wing, a section of the existing wood framed floor structure (over a utility basement) is separated from the adjacent wall and has begun to sag. This condition is further evidence of ongoing settlement problem that appears to be a consistent issue throughout the facility.

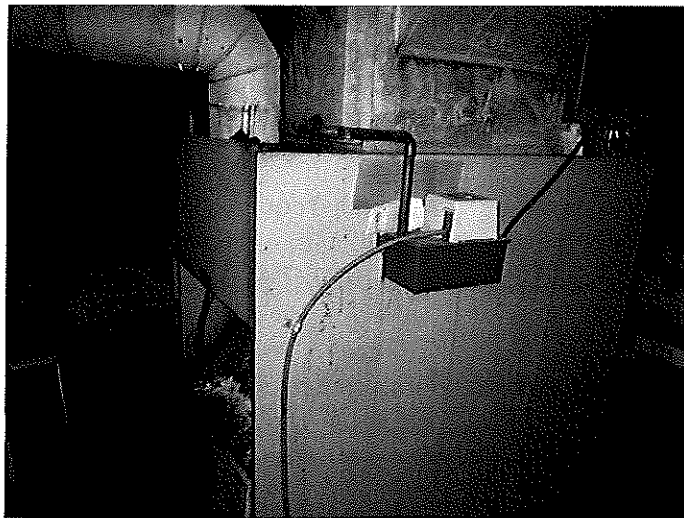
Office Area Furnace / Air Conditioner

The office area is served by a single zone oil fired furnace with split system air conditioning. The furnace is beyond its useful life and in need of replacement. There are several rooms in the office area that are cold in the winter and hot in the summer due to one single thermostat location.

For the office area, we would recommend a new energy efficient variable air volume (VAV) system with individual room temperature controls. Unit heaters and/or unit ventilators would be provided for the Bay areas, as well as improved vehicle exhaust and ventilation systems.

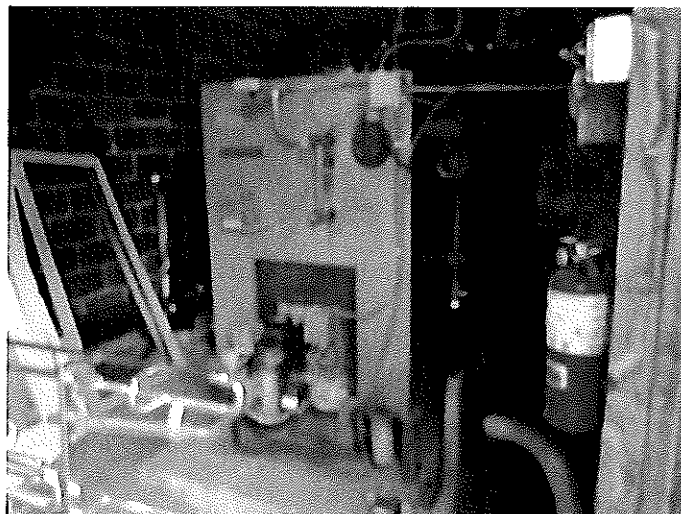
Steam Boiler

The Workshop and Bay areas are heated by a single HB Smith steam boiler that is approximately 20 years old. The boiler is rated for approximately 1,000,000 btu/hr and feeds steam unit heaters in the Workshop and Bays 1-5. There is also a waste oil fired unit heater in Bay 5 that consumes all waste oil recovered at this facility.

The steam boiler is said to be temperamental, requiring frequent maintenance and tuning. Space temperature control for the Bay areas is lacking, with only one thermostat controlling the boiler. Several of the existing steam unit heaters are not working and some of the Bay areas are quite cold during extreme winter conditions.

For continued use of this facility, the Consultant recommends replacement of all existing HVAC systems. We would recommend starting with the steam boiler replacement, converting the heating system from steam to hot water. This would enable individual temperature control zones for the office areas as well as each individual Bay and Workshop area. The new system would have multiple temperature control zones with individual circulator pumps and/or zone valves. It would be preferable to have two boilers with some redundancy in case of failure.

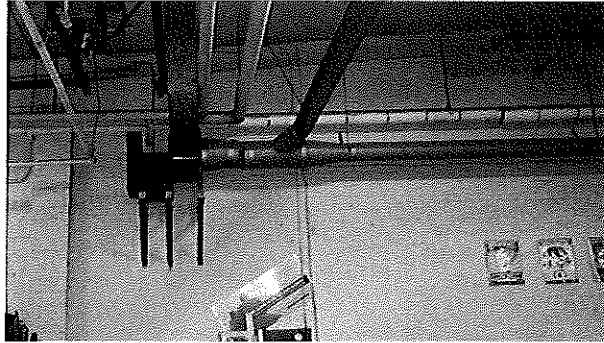
Vehicle Exhaust Blower Mounted on Wall in Maintenance Bay

Bay areas used for vehicle maintenance are equipped with vehicle exhaust systems. The exhaust fans are old but still operational. The Bay areas also have carbon monoxide monitoring tied into control of rooftop exhaust fans.

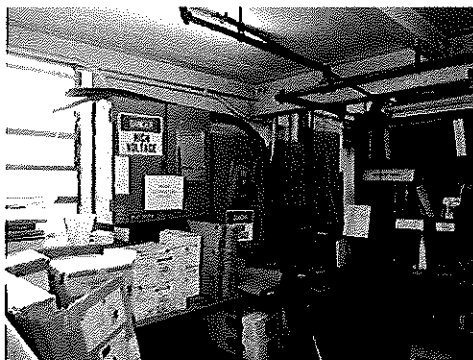
Main Electric Service & Distribution

The main service fused disconnect switch is manufactured by General Electric and is rated at 400A, 208Y/120V, 3-Phase 4-Wire. There is a utility CT cabinet adjacent to the main service disconnect switch with the utility meter located in the same room on the adjacent wall. The area in front of the main service

disconnect and distribution was blocked by work tables and benches in violation of Massachusetts Electric Code (MEC) Article 110.26(A)(1).

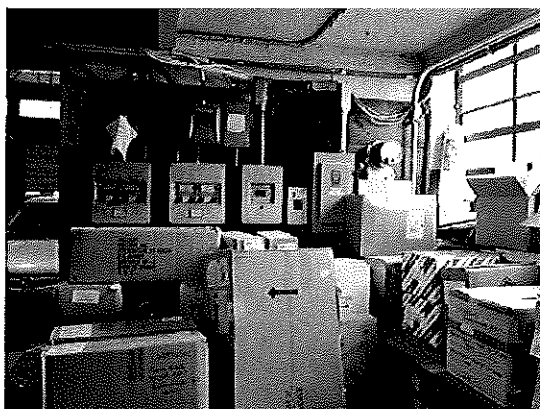
Electric Distribution

The electrical distribution is comprised of panelboards of several different manufacturers (i.e. Yankee Electric, General Electric and Square D). The facility also contains small circuit breaker enclosures which appear to be served from the main panelboard. It also appears that a tap was made to the main service feeders to serve panelboards located in the garage addition.

The buildings power distribution is in poor condition and has reached the end of its useful life. Requests for utility metering information have been forwarded to the building owner. This information will help determine the building's power consumption and peak demand use in order to assess the building's available spare electric service capacity.

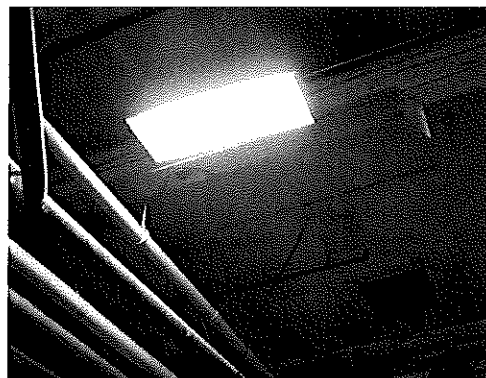
Garage Area Lighting

The garage area lighting consists primarily of fluorescent, high-bay type fixtures. In general, light levels appear sufficient for the function and activity of the areas served. The office and garage area lighting fixtures appear to have been installed within the last 12 years. It was apparent that several of the newer fixtures have damaged lenses and/or failed lamps. The overall condition of the interior lighting is fair.

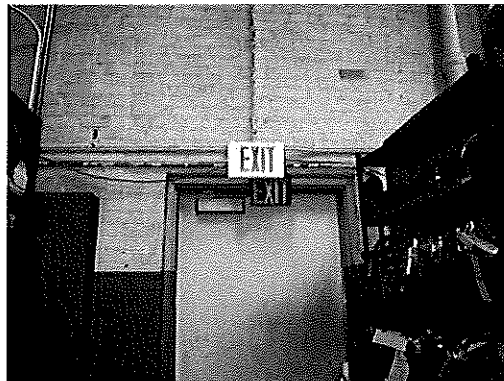
Maintenance Shop Exit Signage (LED and non-illuminated type exit signs)

Non-electric exit signs do not illuminate upon loss of power and there is no emergency lighting fixture located nearby to illuminate the signage during this condition. This condition is in violation of Massachusetts Building Chapter 10 – Means of Egress.

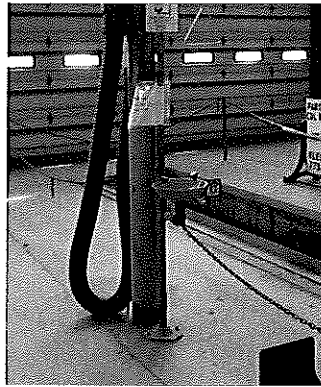
Emergency Eyewash Shower

The entire facility has only one Men's and one Woman's restroom located in the office area. There are no restrooms convenient to the Bay areas. The existing restrooms are not handicap accessible. There are emergency eyewash/shower stations in the Bay areas but they are fed with cold water. Current codes require tempered water supply for these emergency stations.

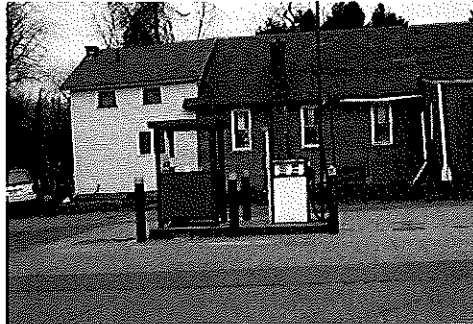
Vehicle Fueling Station

There is an existing gas/diesel fueling station located on site. The underground tank is a divided tank with 2,000 gallons of gas and 10,000 gallons of diesel storage. The tank and piping are double wall systems with required leak detection. It appears that the system meet current code requirements.

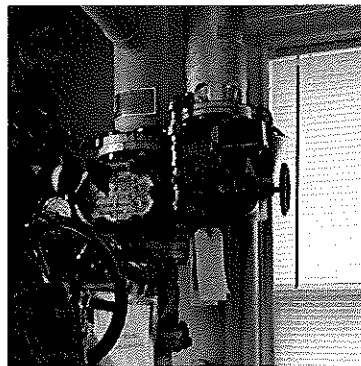
Fire Protection Riser in Office Area

The building is equipped with an automatic fire protection sprinkler system. It appears that all areas of the facility have sprinkler coverage. The sprinkler risers are not equipped with code required backflow preventers.
