Franklin Regional Transit Authority

Operations Facility Needs Assessment

June 2012

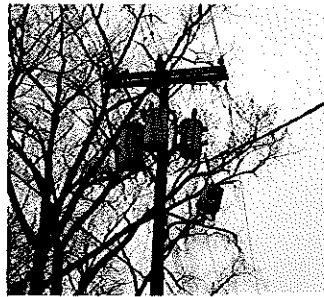
The facility is fed from Western Massachusetts Electric Company (WMECO) pole mounted transformers on WMECO span pole #6443-1, located along the southeast side of the building. These transformers are fed via primary overhead feeders from WMECO pole #6443 on Deerfield Street.

WMECO Pole #6443-1 with Pole Mounted Transformers

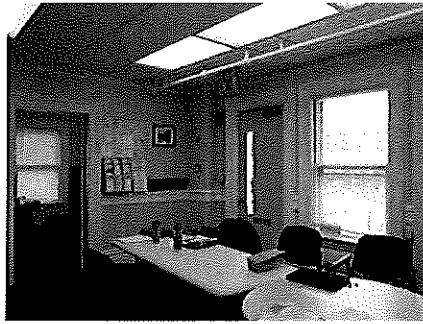
The garage area lighting consists primarily of fluorescent, high-bay type fixtures. In general, light levels appear sufficient for the function and activity of the areas served. The office and garage area lighting fixtures appear to have been installed within the last 12 years. It was apparent that several of the newer fixtures have damaged lenses and/or failed lamps. The overall condition of the interior lighting is fair.

Office Area Lighting (w/incandescent exit sign)

Non-electric exit signs do not illuminate upon loss of power and there is no emergency lighting fixture located nearby to illuminate the signage during this condition. This condition is in violation of Massachusetts Building Chapter 10 – Means of Egress.

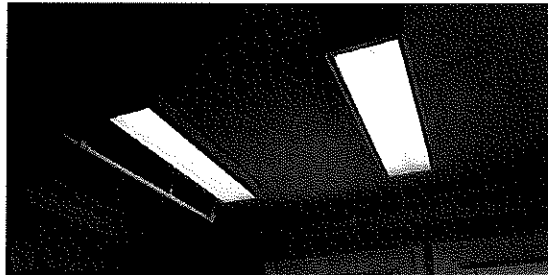
Private Office Area Lighting

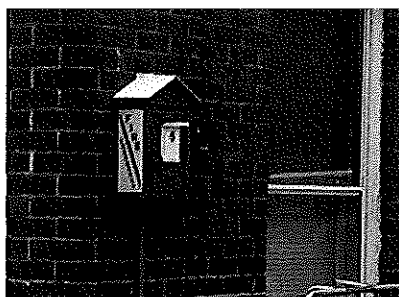
The facility currently does not contain a fire alarm system. The sprinkler system has a water flow switch located at the service entrance point which transmits an alarm to the fire department through the building mounted Master Box which is tied to the City's municipal loop. It does not appear that the sprinkler system is monitored or that annunciation is provided throughout the facility in violation of Massachusetts Building Code Chapter 9 – Automatic Sprinkler Systems. Annunciation appears to be limited to a bell and water motor gong located on the building exterior.

Fire Alarm Master Box #955

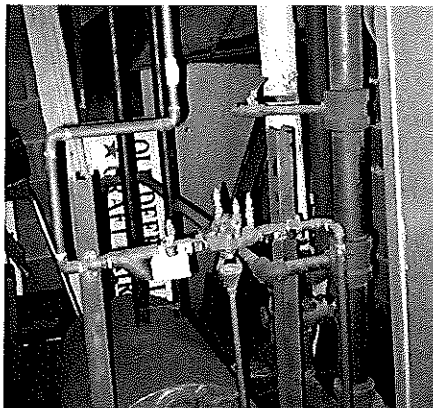
Makeup water supply for the steam boiler is equipped with a backflow preventer, as required by code. Wash stations for vehicle cleaning are also protected by backflow preventers. The wash bay has a trench drain system that had standing water in it at the time of our survey. We were unable to determine if this was due to drain plugging or improper pitch of the trench drain. The wash bay drainage system is equipped with a code required oil/water separator system with proper access for cleaning. Floor drains in other Bay areas are capped to prevent accidental discharge of vehicle fluids. The maintenance bays are also equipped with a compressed air distribution systems for pneumatic tools with a relatively new air compressor.

Water Backflow Preventer
